Proceedings of the ARPA/AFML Review of
Progress in Quantitative NDE, July 1977–June 1978

Preliminary Evaluation of NDE Techniques for Structural Ceramics

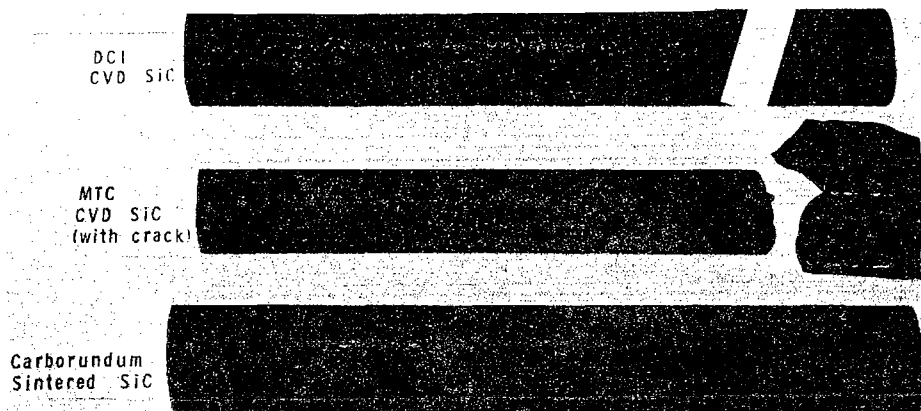
Fig. 2

DYE ENHANCED RADIOGRAPHY

The first figure shows two silicon nitride rotor blade rings (supplied by Ford Motor Co. for this study) and three silicon carbide heat exchanger tube samples representative of those investigated. The next figure shows schematically the procedure for dye-enhanced radiography where surface flaws filled with an x-ray absorbing dye may be revealed even though missed with conventional radiographic techniques. The third figure shows the mass absorption coefficient ratio for silver nitrate to silicon nitride indicating an absorption edge at 25 KeV. Conventional x-ray machines have a broad spectrum up to a maximum energy value. The optimum setting for a silver nitrate dye appears to be around 50 KeV maximum. Figure 4 shows (for the purpose of illustration) the results using a cracked plastic rod. Figure 5 shows a cross section of a silicon carbide tube (1 mm thick wall) indicating two cracks. The larger crack was detected by both conventional and dye-enhanced radiography; the smaller only by dye-enhanced radiography. Dye-enhanced radiography appears to be useful for detection of tight cracks
